# 1 UAV Photogrammetry, Infrared Thermography and GPR for 2 Enhancing Structural and Material Degradation Evaluation of the 3 Roman Masonry Bridge of Ponte Lucano in Italy

12 This paper presents a case study regarding the cooperative use of non-destructive  
13 contactless diagnostic investigations as a tool to aid and assist the degradation  
14 evaluation of an iconic Roman masonry bridge: Ponte Lucano in Tivoli, Italy.  
15 Specifically, unmanned aerial photogrammetric surveys are considered to  
16 perform detailed visual inspections and obtain a geometrical 3D model; infrared  
17 thermography analyses are carried out to characterize the thermal surface map of  
18 the structure detecting anomalies related to material degradation, such as the  
19 presence of humidity; ground penetrating radar investigations are performed to  
20 improve knowledge of the bridge subsurface structure. The results of the analyses  
21 demonstrate that the integration of mentioned diagnostic tools provides  
22 information regarding the degradation state of the stones and its causes, as well as

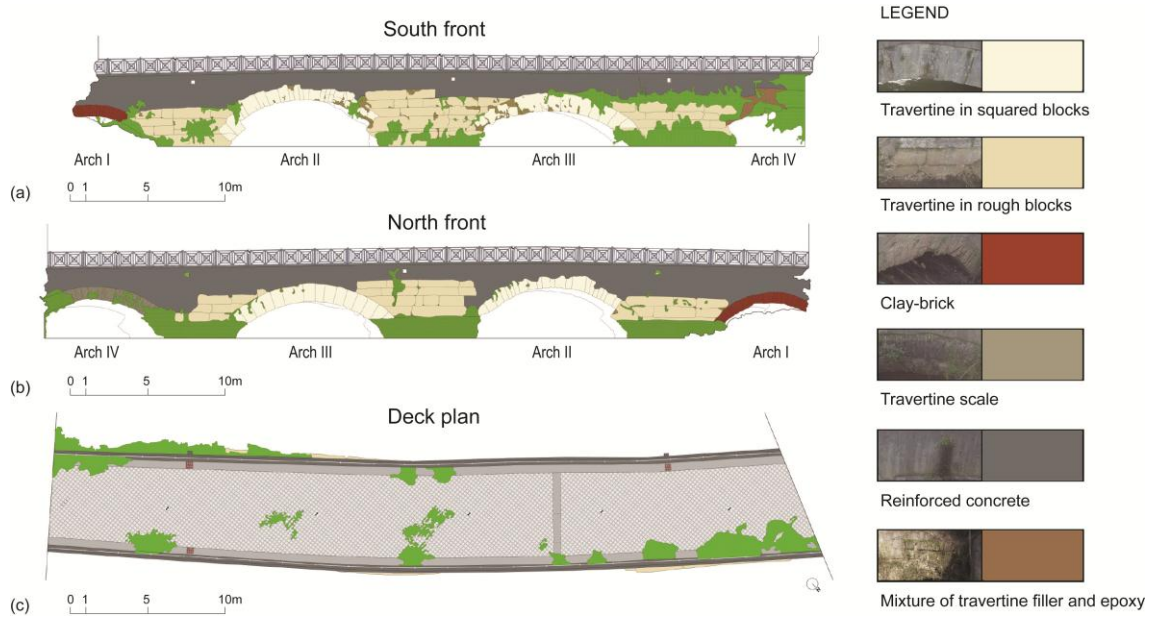
In Figure 8 a manual classification map of the main materials is illustrated, in which the sequence of the restoration and/or reconstruction processes described in Section 2 can be identified. Starting from the East side, Arch IV consists of several materials: on the North front there is an arch made of travertine scales, while on the South front the arch was covered with a mixture of travertine filler and epoxy during the

last restoration works. Arch III, made of travertine squared blocks, seems to be the one belonging to the original construction.

Arch II, in fact, even if constituted by travertine squared blocks, presents large blocks at the impost of the arch, what suggests that in a certain period of the past the arch was rebuilt to increase the span. Arch I has a singular aspect, being composed by several arches also with different shapes that have been constructed throughout the centuries. The external arches that are visible today date back to the restoration works of the 19<sup>th</sup> Century and are made of brick masonry. The external walls of the piers are made of big travertine blocks and, finally, the continuous strip of reinforced concrete material is placed above the arches and the piers along all the bridge.

Figure 8. Map of the constituent materials observed on the South front (a), the North front (b) and the deck (c) of Ponte Lucano.

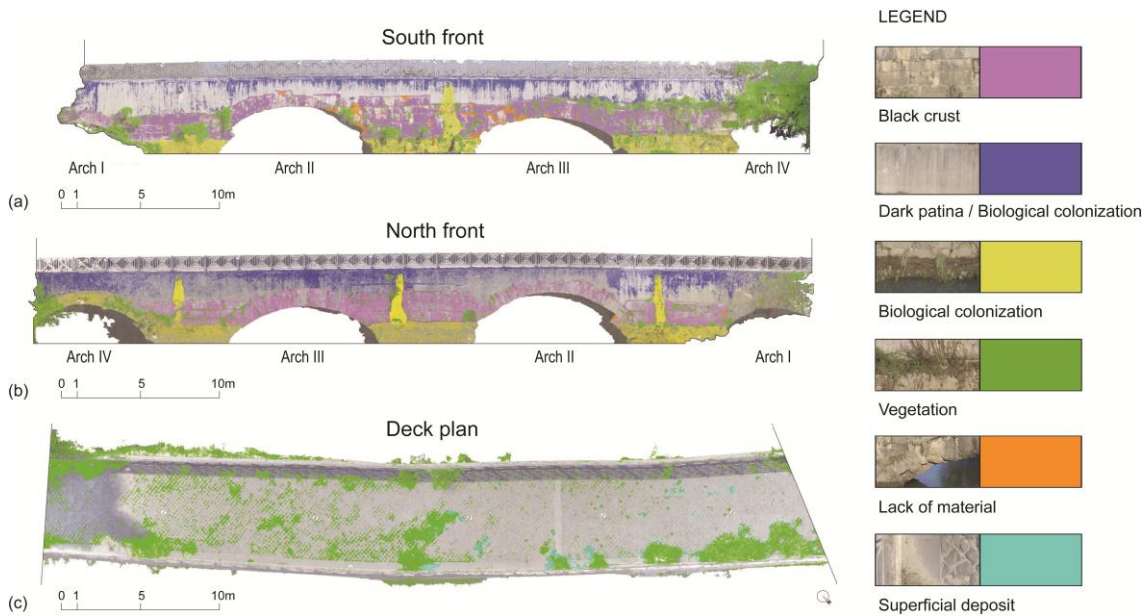
The significant heterogeneity of the constituent materials determines, as a consequence, a variety of degradations affecting them. In order to carry out a classification of the material degradations consistent with the scientific literature, the analysis was referred to the ICOMOS glossary on stone deterioration patterns, which actually represents «an important tool for scientific discussion on decay phenomena and processes» and «an excellent basis for tutorials on stone deterioration» [59]. In Figure 9 a map of the main degradations observed on the structure, obtained through an automatic color mapping procedure as explained in Section 3.1, is illustrated. As far as it concerns “Discoloration and Deposit” category, both black crusts and superficial deposits are visible on the travertine stones, together with material losses related to both the impact of materials during flood events and internal stresses which could have been generated by different causes, namely thermal stresses, increase of active loads and more. The concrete material on the other hand is mainly affected by a dark patina related to the water percolation from the deck level and, consequently, by a biological

patina, which is more widespread on the North front. On the other hand, the South front, too longer exposed to the sunlight, is characterized by a significant presence of vegetation that would require constant maintenance activities.

Figure 9. Map of material degradations observed on the South front (a), the North front (b) and the deck (c) of Ponte Lucano.

The black crusts can produce, over time, serious injuries or rifts caused by the sulphatation of limestone elements or a bad surface thermal distribution. Moreover, the high concentration of humidity in the air and the poor quality of the water of the Aniene river have favored the deposition of dust amplifying the black crusts. Equally, the dark patina of the concrete material has increased the risk of thermal inhomogeneity which can generate, with the concentration of humidity during the day, surface cracks or detachments of material. In addition to the above, the presence of small vegetation, grown between the joints of natural stones, has amplified the risk of splits. The mutual interaction of the material degradation can cause through the years significant problems on the overall stability, especially when the bearing structural parts are particularly

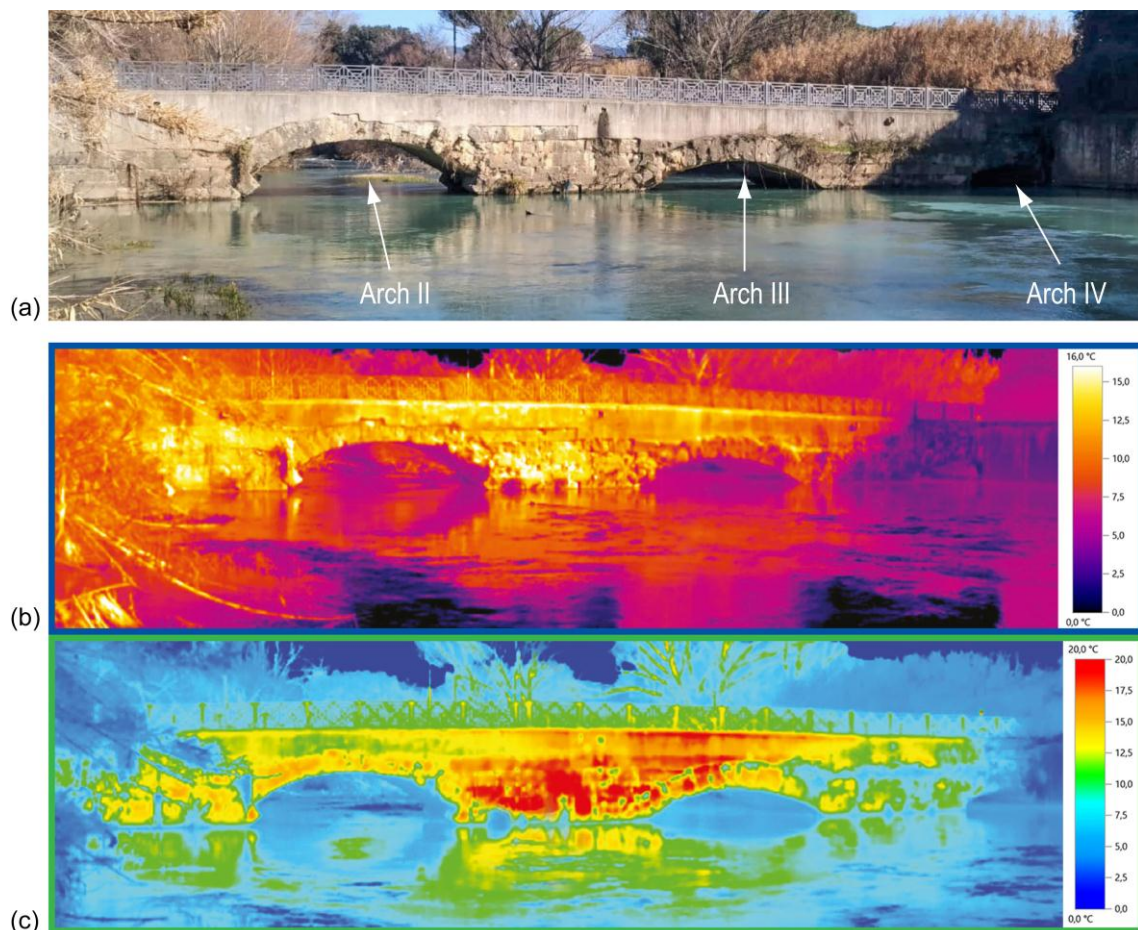
Figure 11. (a) Image of the South front of Ponte Lucano. (b) Thermal image with solar radiation (11.30 a.m. of January 26th). (c) Thermal image in absence of solar radiation (05.00 p.m. of January 29th).

Figure 11(b) shows the thermal image of the South side of the bridge in the morning with direct solar radiation (first campaign). The irregular temperature map is also evident in the concrete surface above the masonry arches, highlighting the zone of the bridge that is mostly affected by humidity retention. In the masonries, the irregularities in temperature ( $\pm 5^{\circ}\text{C}$ ) can be observed in correspondence to the black crusts and lacks of material, in which the gradient of thermal stresses can exacerbate material degradation in relation to the presence of humidity due to freeze/thaw cycles. Moreover, the presence of vegetation can induce significant thermal stresses on the masonry, which are more emphasized in the case of dry vegetation with respect to the alive vegetation, owing to passive heat reduction properties that smooth the differences in temperature. On the other hand, the alive vegetation can lead to the increase of mechanical stresses induced by the roots developed in the joints between the mortar blocks and in the lacks of material. Figure 11(c) depicts the temperature map in absence of solar radiation (second campaign) and after rainy days. The pier between Arch III and Arch IV exhibits a lower temperature, probably due to a more significant presence of water inside the structure and a lower exposure to sunlight with respect to the central pier. The irregularities in temperature (of about  $\pm 3^{\circ}\text{C}$ ) are locally present in Arch III, which results the most degraded one, and on the longitudinal development of the concrete wall, revealing the parts of the bridge where the water flows may be prevented. More detailed images obtained from Position 2 (Figure 10) of the South front of the bridge (Figure 12(a)) and of Arch IV on the East abutment (Figure 12(b)), shot during the first and the second campaign, respectively, highlight the aspects described above. The main aspect worthy of note is that Arch IV on the right is constantly in the shade, due to the presence of the nearby structural bank, which is higher than the arch, preventing the direct solar radiation during the whole day. The surface temperature is

not homogeneous both in the morning and in the afternoon, with clearer gradients in the material of the two central arches and in the pier between them, due to a more prolonged exposure to sunlight of the left arch. Moreover, the presence of a drainage duct in the adjacent corner between the embankment and the first arch on the right amplifies the thermal heterogeneity on the area.

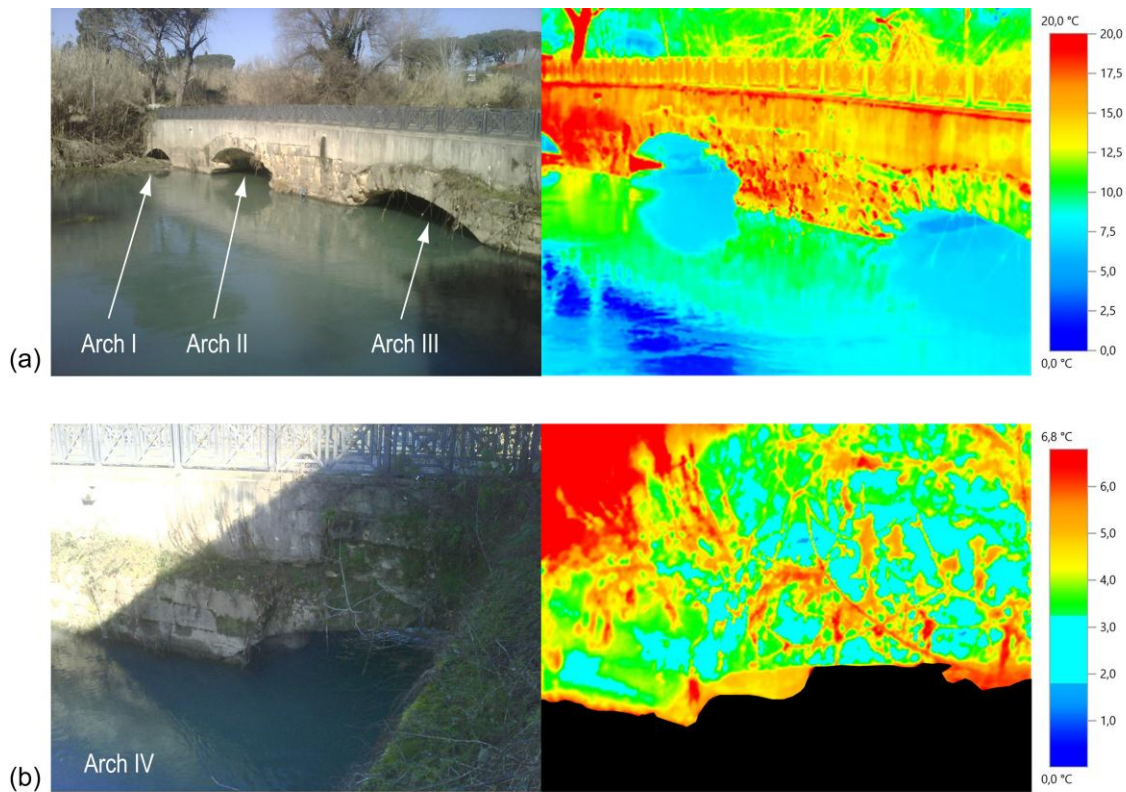
Figure 12. (a) Photographic and thermal image of the South front of Ponte Lucano shot from the Position 2. (b) Photographic and thermal image detail of the arch near the East abutment of the bridge.

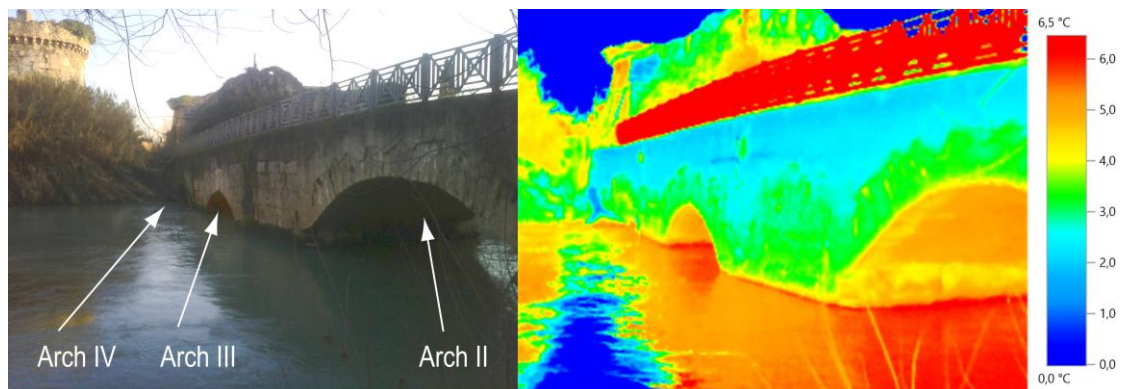
Figure 13. Photographic and thermal image of the North front of Ponte Lucano shot from the Position 4.

Figure 13 shows the thermal image of the North side of the bridge, as shot in the morning (first campaign), that remains in the shade almost all day long. The temperature map is more homogeneous in the constituent materials, mainly the travertine stones and the concrete, besides the steel balustrade. The concrete surface appears to be colder than the other materials (of about 2-3°C), mainly for its lower thermal conductivity, but also for the presence of a widespread biological patina, which particularly affects the porous surfaces. Other cold parts are visible in correspondence to the black crusts and in the areas where biological patina cover the stones. As already observed in the previous Section, the North front of the bridge appears to be less degraded with respect to the South front in terms of lacks of materials and presence of vegetation, confirming that the continuous exposure to solar radiation favors the growth of vegetation, while a strong presence of humidity combined with freeze/thaw cycles creates quite unfavorable conditions for material conservation. In Figure 14 a detailed image of the brick masonry Arch I, near the West abutment, highlights the presence of local damages, both on the concrete wall and on the brick masonry arch, probably due to the hits of large woody debris occurred during flooding events.

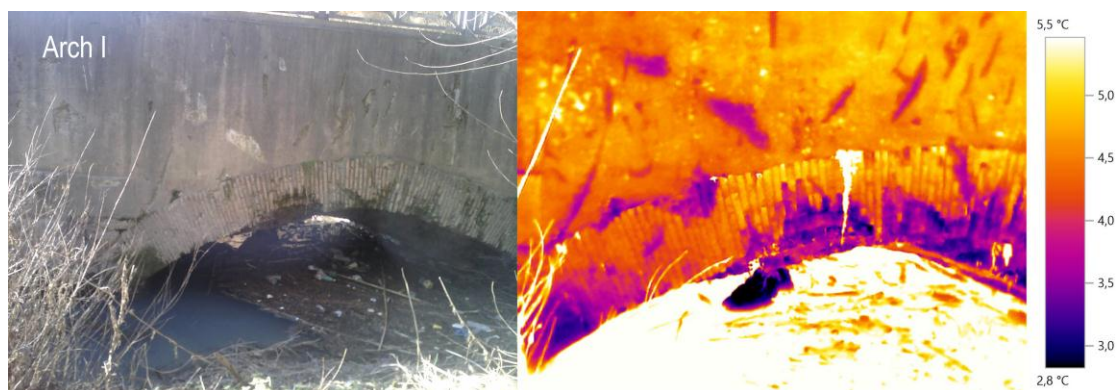
Figure 14. Photographic and thermal image detail of the brick masonry Arch I, near the West abutment of the bridge, shot from the Position 3.

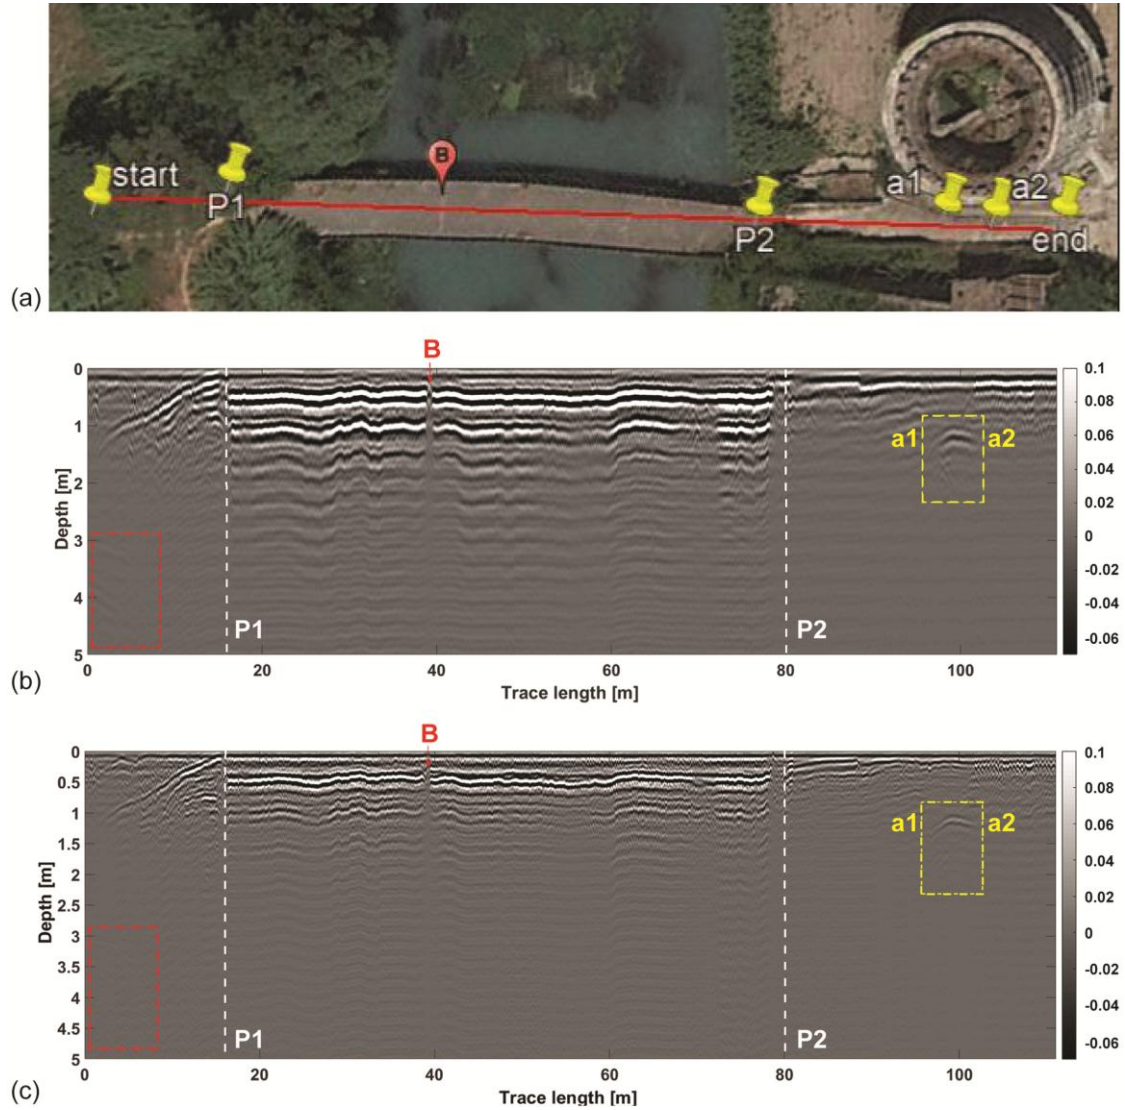
Figure 15 (a) shows a plan view of the GPR trace, where P1 and P2 denote the limits of Ponte Lucano as it appears nowadays, i.e. after the last restoration actions; the pointer B indicates a visible leucite or basalt stone block; a1 and a2 identify the west and east sides of an extended buried anomaly, which can be observed into the filtered radargrams at 200 MHz and 600 MHz, shown in Figures 15(b) and 15(c), respectively. Let us note that the vertical axis provides the depth instead of the time and the time-

Figure 15. GPR survey: (a) Plan of the GPR inspection with indication of the strating and the end points of the trace covering the entire bridge; (b) 200 MHz filtered radargram; (c) 600 MHz filtered radargram. In the figures, P1 and P2 denote the limits of Ponte Lucano as it appears nowadays, the pointer B indicates a leucite or basalt stone block, while a1 and a2 identify the west and east sides of an extended buried anomaly, visible in both the filtered radargrams.

As it can be observed from Figure 15 the filtered radargrams at 200 MHz and 600 MHz provide comparable images wherein several subsurface features appears, of course

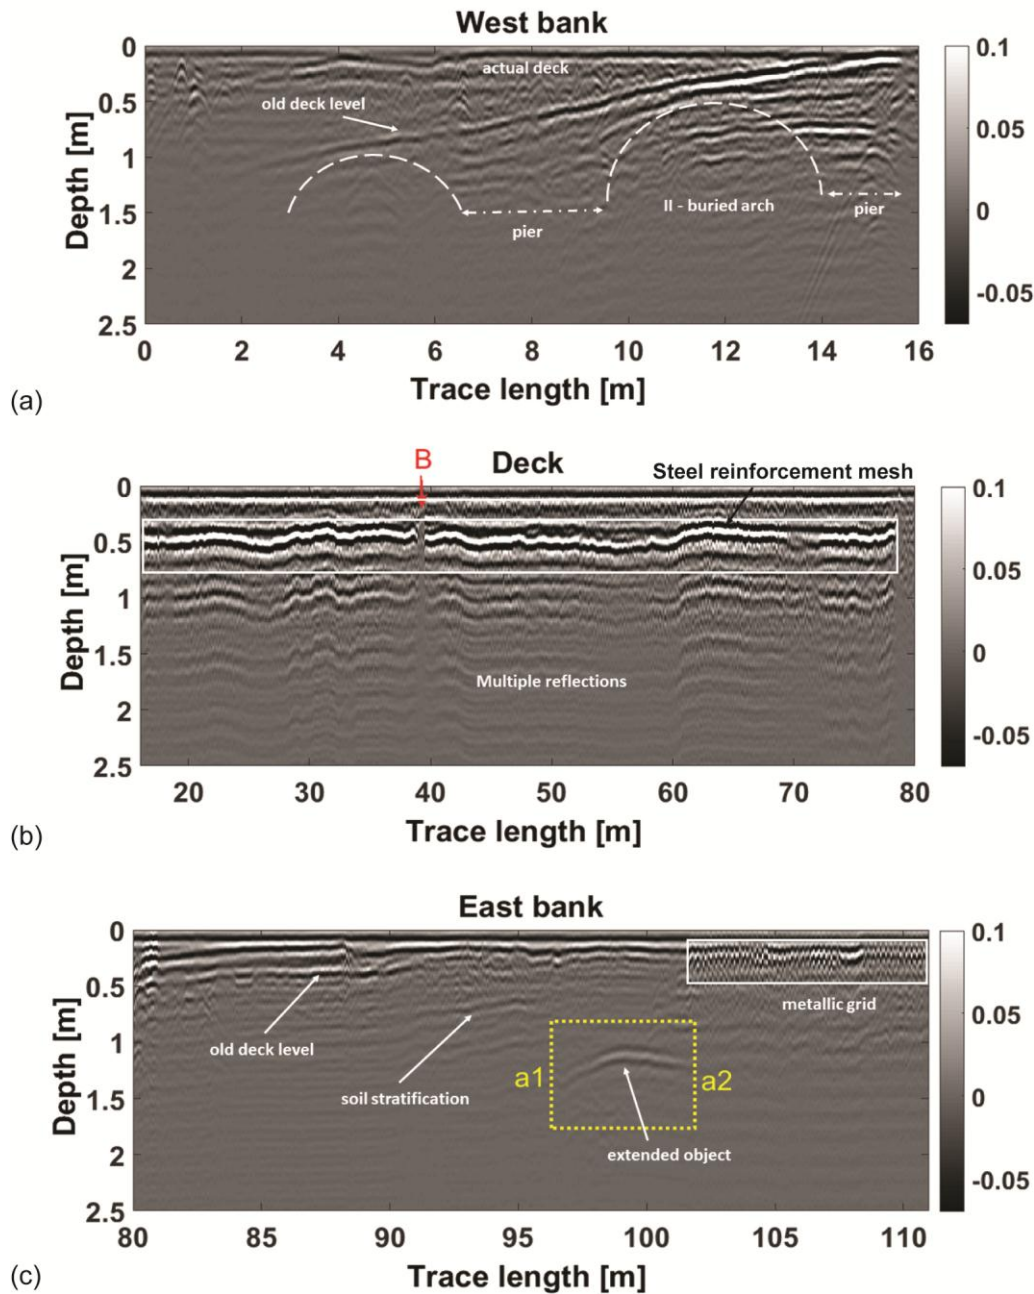
Figure 16(a) corresponds to the North side of the bridge and shows the presence of buried structures, which could be the structural elements of the ancient bridge covered by the deposit materials of the river banks. Specifically, two deck levels are visible. The flat one, highlighted by a white line, is detected in the entire radargram portion at a depth of about 0.1 m and represents the current level. The oblique one starts at  $x = 2$  m with depth decreasing from 1.5 m to 0.1 m for increasing  $x$  values and corresponds to the old deck level of the bridge. Moreover, below the old deck level, several widespread scatterers appear, including a strong flat reflector extended from  $x = 11$  m to  $x = 15$  m at a depth of about 1 m. These deep electromagnetic anomalies could be related to ancient structural parts of Ponte Lucano not anymore visible as well as material deposits due to the restoration actions performed during the bridge history. In

particular, they could denote buried and filled arches as well as the pier between the buried arches and the pier at the beginning of the actual bridge portion. Such an interpretation is supported by the historical images of the bridge (e.g. see Figure 4(b)), which show that Ponte Lucano was made by two filled arches. The buried arches and piers are sketched in Figure 16(a) through dashed white lines.

Figure 16. Portions of the 600 MHz filtered radargram: (a) West bank; (b) Actual deck; (c) East bank.

Figure 16(b) shows the radargram portion corresponding to the current out-of-banks bridge, allowing the localization of the deck level and the arrangement of the stone pavement, as well as of the concrete reinforcement structure, which appears at a depth of about 0.5 m. In addition, the strong discontinuity at  $x = 39$  m corresponds to an absence of recorded signal due to the presence of a leucite or basalt stone block on the deck level, which is observable by means of a visual inspection and does not permit the propagation of the signal into the medium. On the other hand, the metallic reinforcement structure, positioned during the last restoration actions, generates multiple reflections and does not allow the detection of the bottom of the deck and the position of the arches. This happens also if the 200 MHz radargram is considered (see Figure 15(b)).

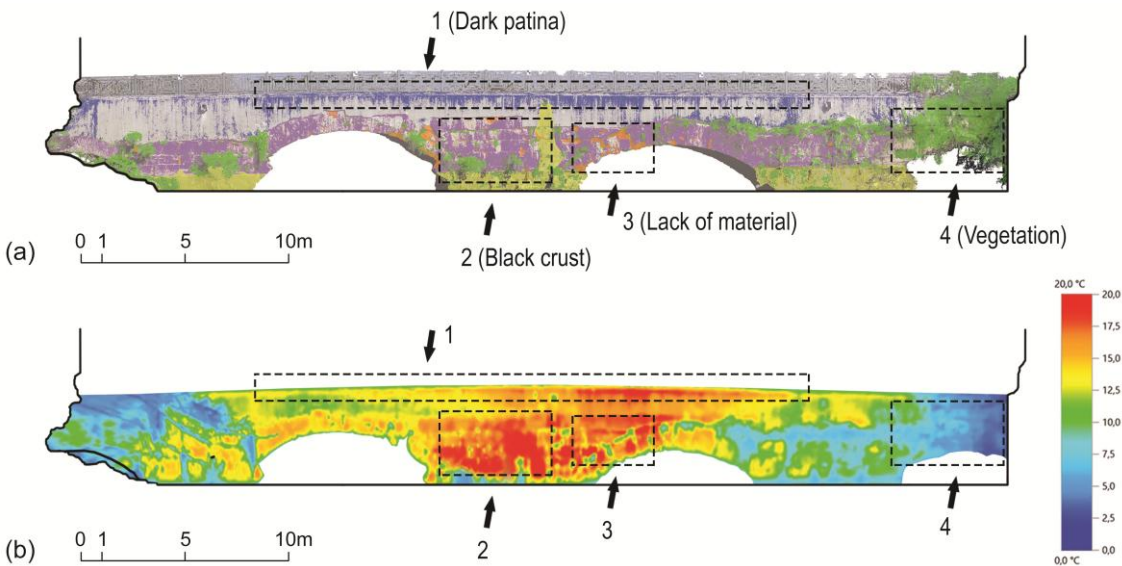
Figure 17. Comparison between material degradation map (a) obtained by UAV photogrammetric survey and thermographic inspection (b) on the South side of the bridge. For the map legend of material degradation refer to Figure 9(a).

Figure 17 highlights interesting links between the color maps identifying the material degradation (Figure 17(a)) and the superficial temperature observed through thermography. Although no direct correlations can be established a priori between the phenomena causing the two color maps, the temperature scale can reveal in some cases

specific degradations, especially in the presence of humidity, to which correspond different levels of heat transfer through the materials, thus different levels of superficial temperature. For example, to the patina of the concrete wall upper side (enclosed in the window 1) corresponds a scale of temperature with no particular meaning in the degradation identification. On the other hand, the black crusts indicated in the window 2 are more evident, due to the chemical-physical characteristics of the external layers of the stones, which affect the heat transfer properties. This aspect is strengthened by the presence of areas with lack of materials, e.g. see window 3, where the absence of the black crusts determines a high gradient of temperature. Finally, in presence of vegetation and biological patina (window 4), directly related to humidity, lower levels of temperature can be observed.

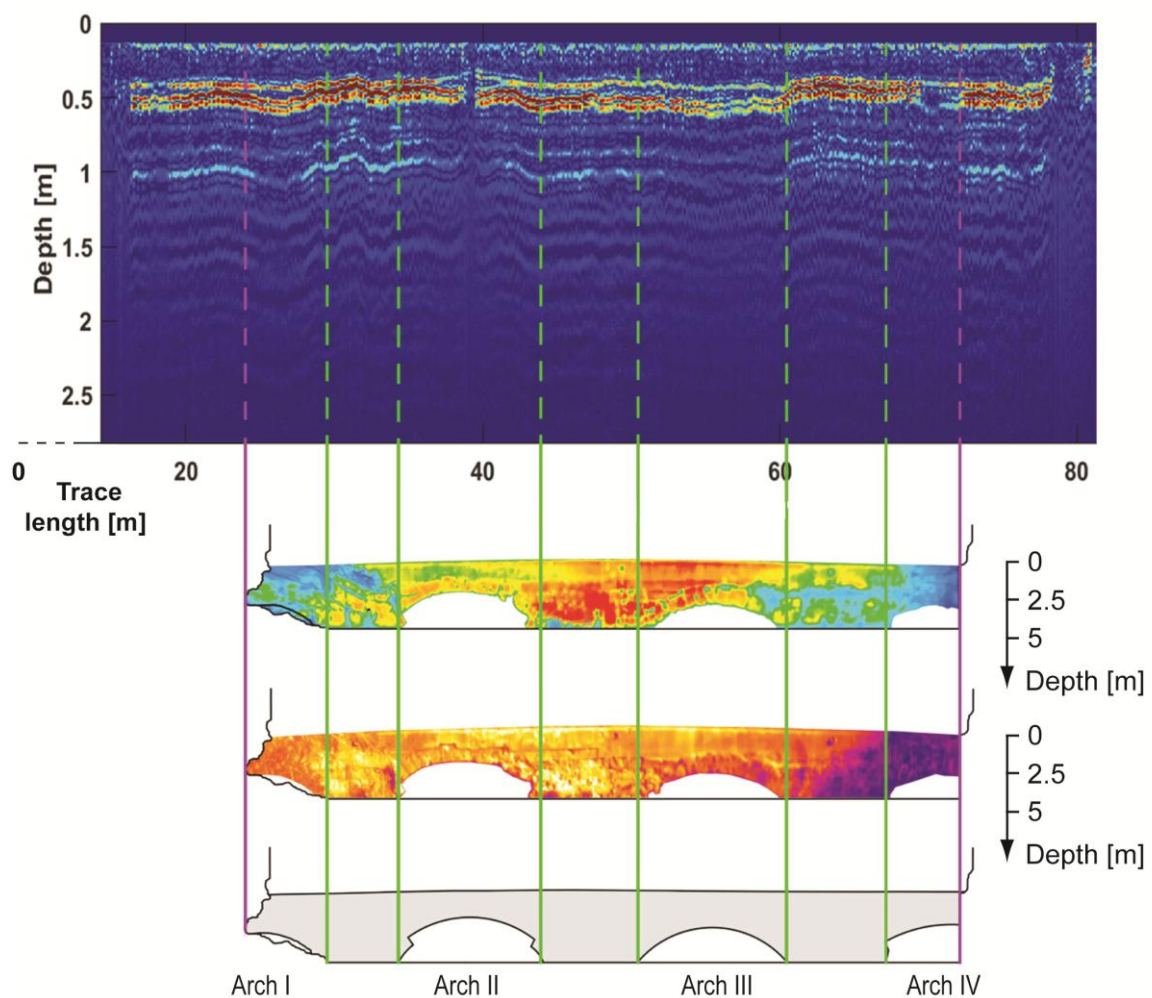
Figure 18 summarizes the results of the combined investigations through the superposition of the filtered radargram at 600 MHz and the thermal images of the South side of the bridge. The alignment of the bridge profile was carried out through the analysis of the radar signal that clearly identifies the beginning and the end of the deck. In a first visual comparison between the radargram and the bridge profile multiple reflections appear in correspondence of the actual deck, i.e. about from  $x = 16$  m to  $x = 80$  m, which are due to the presence of the metallic reinforcement structure. This latter does not allow the signal propagation and thus the detection of the visible arches. On the other hand, the metallic reinforcement structure does not appear at a constant depth along the path ranging about from  $x = 16$  m to  $x = 80$  m, suggesting that where an increased depth is experienced the relative permittivity is higher than the adopted average value. This is coherent with an increased water content. Moreover a soft signal attenuation is observed over the middle arch, i.e. about from  $x = 54$  m to  $x = 60$  m, while a significant signal attenuation occurs over the first arch of the East side, i.e.

about from  $x = 69$  m to  $x = 72$  m. At the same time, the thermal analysis has highlighted that the East side of Ponte Lucano is in the shade all day long, resulting in high constant humidity levels, especially in the wet seasons. These last considerations induce to suppose that the signal attenuation observed in the East side of the bridge, corresponding to Arch IV, could be related to the high level of humidity affecting the backfill layers.

Figure 18. Comparison between GPR analysis and thermographic inspection.

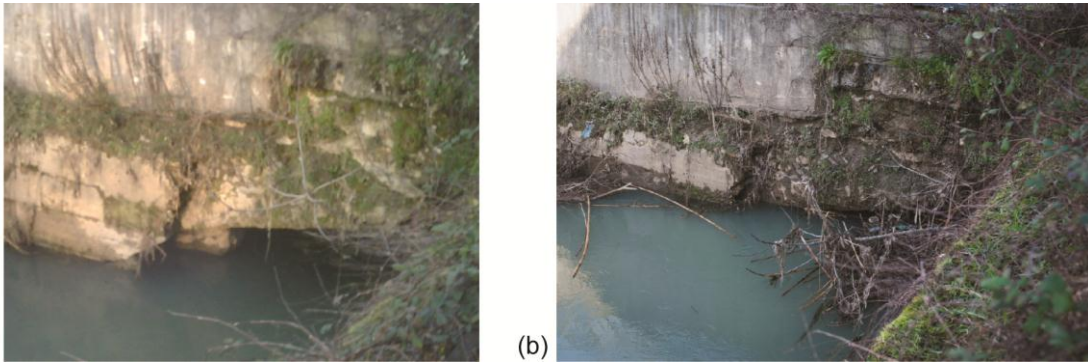
An unexpected consequence of this condition characterizing this side of the bridge is an evident increase of the material degradation occurred in the period of inspection carried out by the Authors. In particular, after a significant rainfalls period, the external

cladding of the South front of masonry arch fell out (Figure 19). That material was applied during the last restoration works, but the environmental conditions were especially aggressive for its durability facilitating the ejection, probably after a progressive separation process due to the presence of humidity.

Figure 19. Increase of material degradation observed on the South front of Arch IV. The images illustrate the arch before (a) and after (b) a heavy rainfalls period.
