1 **Seismic-induced rockfalls and landslide dam following the October 30, 2016 earthquake in**
2 **Central Italy**

28 On October 30, 2016, a seismic event and its aftershocks produced diffuse landslides along the SP 209 road in the
29 Nera River Gorge (Central Italy). Due to the steep slopes and the outcropping of highly fractured and bedded
30 limestone, several rockfalls were triggered, of which the main event occurred on the slope of Mount Sasso Pizzuto.
31 The seismic shock acted on a rock wedge that, after an initial slide, developed into a rockfall. The debris
32 accumulation blocked the SP 209 road and dammed the Nera River, forming a small lake. The river discharge was
33 around $3.6 \text{ m}^3/\text{s}$; the water overtopped the dam and flooded the road. By a preliminary topographic survey, we
34 estimated that the debris accumulation covers an area of about $16,500 \text{ m}^2$, while the volume is around $70,000 \text{ m}^3$.
35 The maximum volume occupied by the pre-existing talus mobilized by the rockfall is about 20% of the total volume.

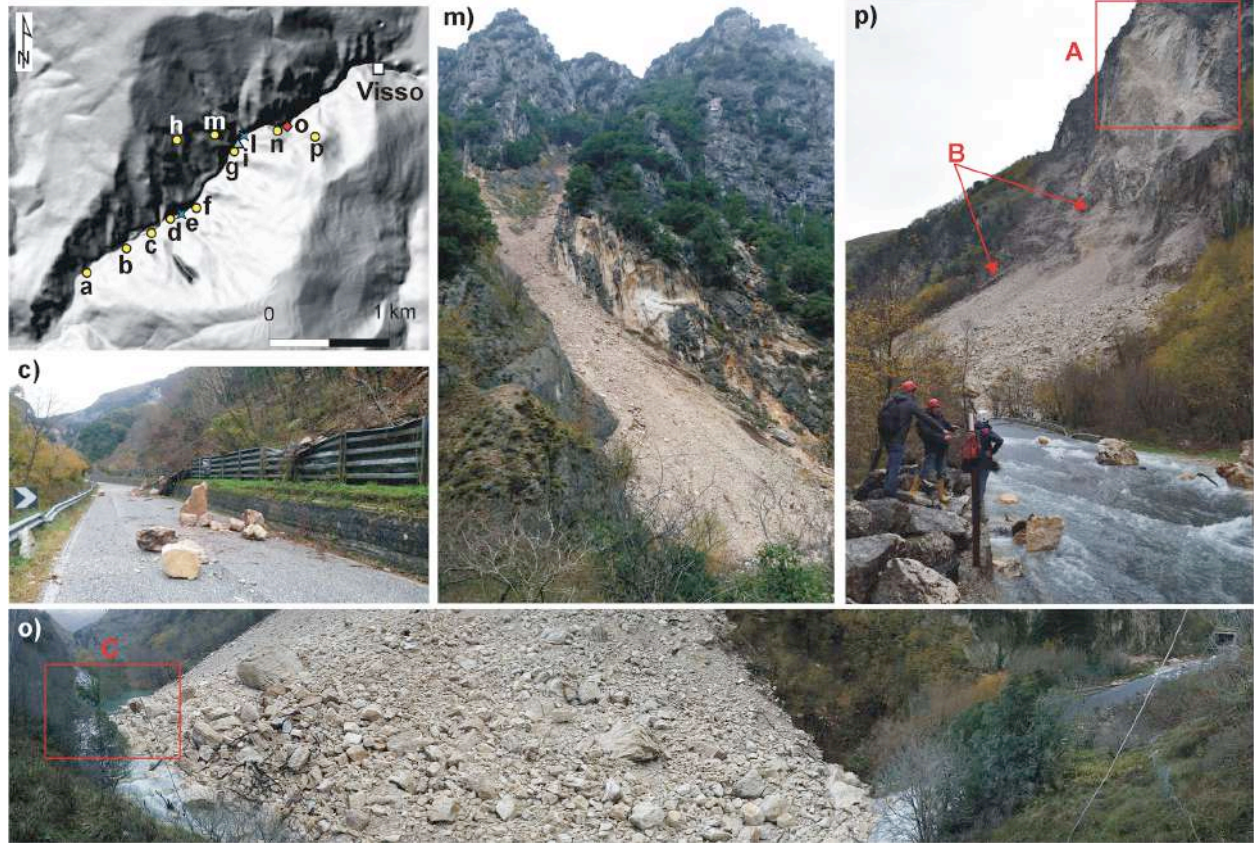
Figure 3 Location of rockfalls and diffuse instabilities along the study area with some pictures of the main

landslides. Yellow dots represent main detached block falls and mass falls along the SP 209 road and debris

accumulation; Red rhombus represent the landslide dam which dammed the Nera River; Blue stars represent

debris accumulation which partially dammed the Nera River; Blue triangle shows the location of main damages

to infrastructures (erosion of road pavement and pillars breaking of rockfall protection tunnel). A) *Sasso Pizzuto*

rockfall source area; B) erosion of existing debris along the slope; C) *Sasso Pizzuto* landslide dam.

117 Figure 3 shows the results of our survey. Along the SP 209 road, we located several boulders and debris from
118 diffuse rockfalls, one landslide dam and debris accumulations which in a few cases partially occluded the Nera
119 River.

130 Rockfall damages were particularly severe along the road stretch between points g and o in Fig. 3 (about 1 km
131 southwest of Visso). The largest rockfall occurred along the steep-faced north slope of Mount Sasso Pizzuto
132 (elevation between 840 and 910 m above sea level, point p in Fig. 3), which is characterized by highly deformed,
133 stratified, and fractured rocks (Maiolica Formation). Seismic shaking acted on a rock wedge (Fig. 5a, b) and, after an
134 initial slide, developed into a rockfall (cf. Cruden and Varnes 1996), which during the fall caused the erosion and
135 entrainment of the existing debris on the slope. When the detached rock reached the base of the slope, it was further
136 fragmented and the final debris deposit obstructed both the Nera River and SP 209 road (Fig. 5c, d).

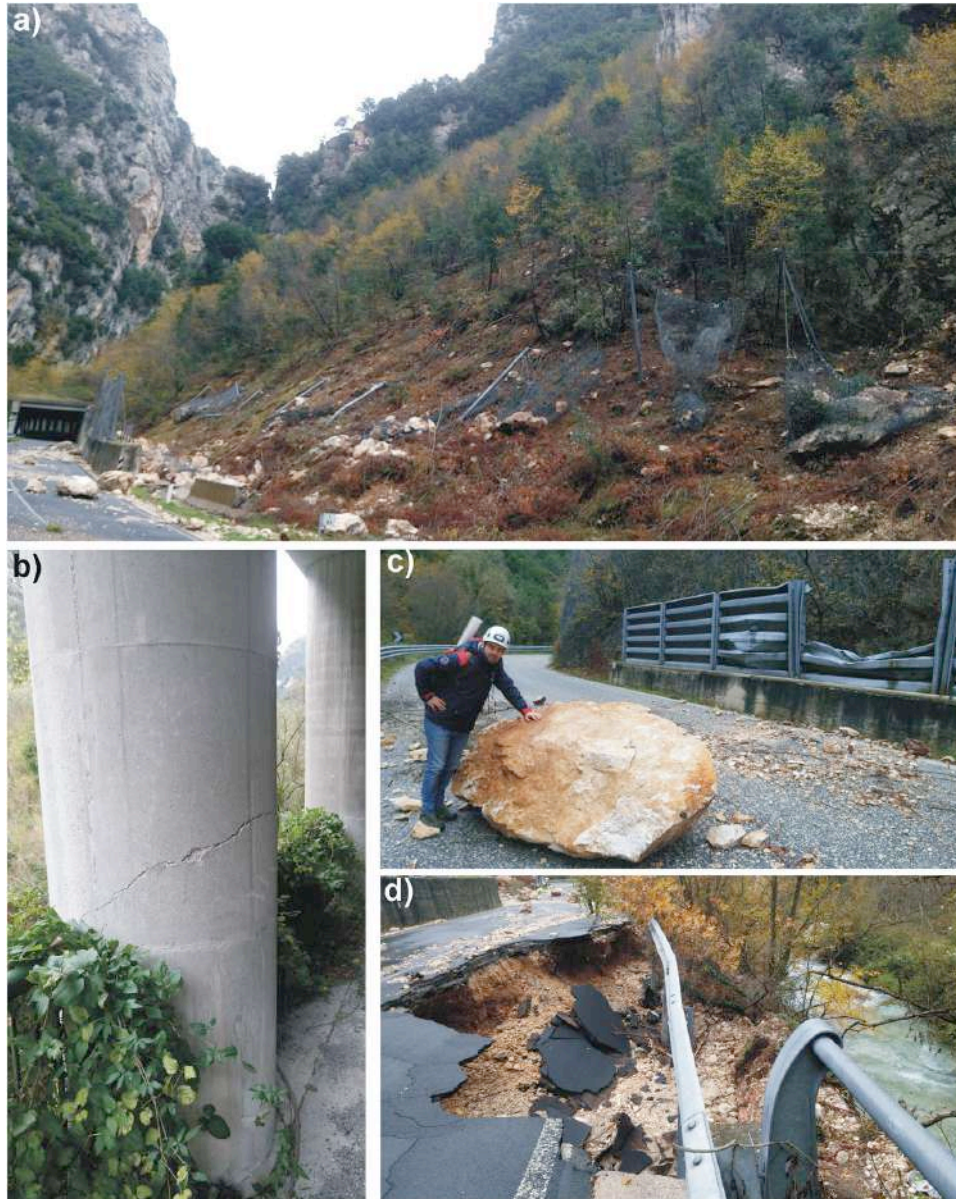
367 Figure 4 Damages to infrastructures induced by seismic activity and related rockfalls within the study area. a)
 368 overturning and displacement of elastic nets (point *g* in Fig. 3); b) pillar breaking and distortion of a rockfall
 369 protection tunnel (point *i* in Fig. 3); c) breaking of rigid barriers by a rock block (point *d* in Fig. 3); d) erosion of
 370 road embankment (point *i* in Fig. 3) by water flow related to landslide dam (point *o* in Fig. 3).

125 It is relevant to point out that the passive protection measures, built after the previous earthquake (Umbria-
126 Marche 1997-1998) along the SP 209 stretch here investigated, were not very effective: most of the elastic nets,
127 rigid barriers, and rockfall protection galleries were severely damaged. Numerous rock impacts seriously damaged
128 the road surface (Fig. 4a, c). Concrete pillars and walls were also damaged (Fig. 4b). Water overtopping the landslide
129 dam also eroded a section of the SP 209 road (Fig. 4d).

248 and rigid barriers within the study area (cf., Fig. 4a, c), indicating that the current defensive measures have been not
249 sufficient for protecting the SP 209 road. In other words, this indicates that the defensive measures were designed
250 for protecting against events of a minor intensity of those produced by the October 30, 2016 earthquake, which was
251 among the strongest of the last eighth centuries. Extensive damage to some of the defensive measures is coupled
252 with further changes in geomechanical properties of rock masses along the slopes due to seismic shaking.
