# 1 UAV Photogrammetry, Infrared Thermography and GPR for 2 Enhancing Structural and Material Degradation Evaluation of the 3 Roman Masonry Bridge of Ponte Lucano in Italy

12 This paper presents a case study regarding the cooperative use of non-destructive  
13 contactless diagnostic investigations as a tool to aid and assist the degradation  
14 evaluation of an iconic Roman masonry bridge: Ponte Lucano in Tivoli, Italy.  
15 Specifically, unmanned aerial photogrammetric surveys are considered to  
16 perform detailed visual inspections and obtain a geometrical 3D model; infrared  
17 thermography analyses are carried out to characterize the thermal surface map of  
18 the structure detecting anomalies related to material degradation, such as the  
19 presence of humidity; ground penetrating radar investigations are performed to  
20 improve knowledge of the bridge subsurface structure. The results of the analyses  
21 demonstrate that the integration of mentioned diagnostic tools provides  
22 information regarding the degradation state of the stones and its causes, as well as

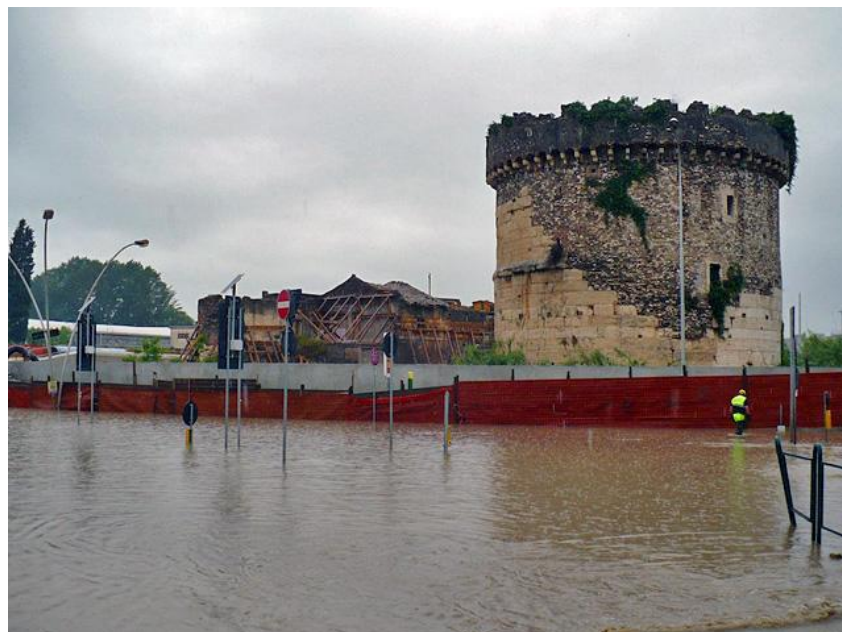
As already introduced, today the main problems of the site are related to flood events of the Aniene river. In the period range of 1914-2001, 23 events that caused damages and evacuations were registered. The present configuration of the segment

between Aniene and Ponte Lucano has been determined by the protective hydraulic interventions that ended in 2004, that put the Monumental Mausoleum of Plautii behind a concrete wall of 4 m height (Figure 2), essentially limiting its use and fruition. This work was also ineffective from a hydraulic point of view. As of today, streets and roads have undergone many inundations (see Figure 5) showing that the problem is far from being solved. The intervention invasively affected the existing landscape, disfiguring and obstructing the sight of the archeological ruins. The wall on the left bank traces a new river course, which blocks the inflow towards the riverbed and hence the mausoleum is constantly exposed to the raising waters of the Aniene river. The situation has yet made worse by the flood waves that year by year become stronger due to both the lack of bank maintenance, which caused the shutdown of 3 out of the 5 Roman bridge arches, and the debris carried by the upstream tributaries. Building dams did not solve the problem of floods in the area and as a supplementary intervention water-scooping devices were installed that absorb water from the street and spill it towards the monument and the river itself.

Figure 5. Image of the flood occurred on May 21st 2008.

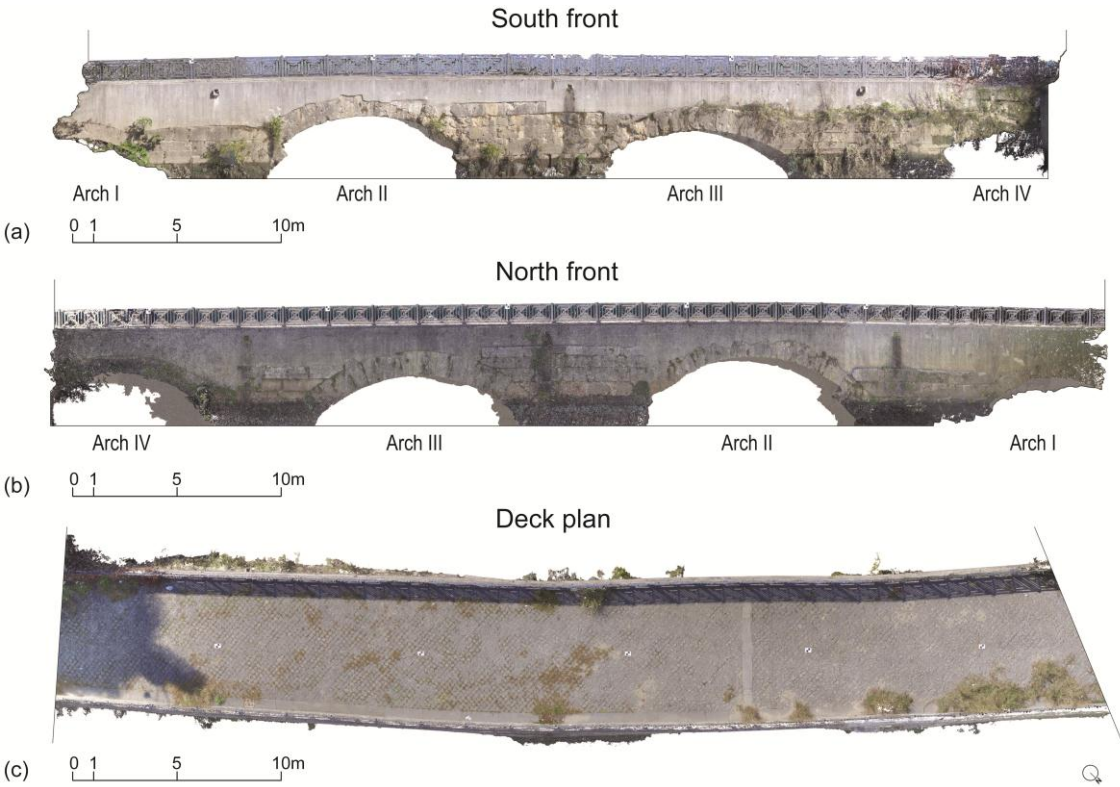
The geometrical survey of Ponte Lucano was carried out by means the most modern techniques of 3D photomodelling and UAV based inspection, which have been characterized by a continuous growing interest during the last years in application to historical structures. The UAV inspection was performed using a DJI Phantom 3 Standard whit 1/2.3'' CMOS Sensor and 20 mm (35 mm format equivalent) f 2/8 lens. Four flights were planned in order to exploit as much as possible the better diffused light conditions for each side. For the North front and the deck of the bridge a morning time slot was chosen, while the afternoon time slot was chosen for the South front. The shots were made on the nadir direction for the deck and on the orthogonal direction to both North and South fronts. Moreover, another series of shots with inclined direction with respect to the horizontal were taken along the development of the bridge in order to superimpose the markers placed on the deck. The 3D photogrammetry procedures allowed to obtain a dense points cloud and thus a 3D model of the bridge, from which orthophoto-plan images on the horizontal direction of the two fronts and the deck plan were extracted (Figure 7). The geometrical survey and the orthophoto-plans obtained by the points cloud were the bases for the analysis of the constituent materials and of their degradation state, respectively. In order to simplify the following descriptions, the arches have been numbered from I to IV starting from the West abutment.

Figure 7. 3D modelling of Ponte Lucano obtained by photogrammetry technique: view of the South front (a), the North front (b) and the deck (c).

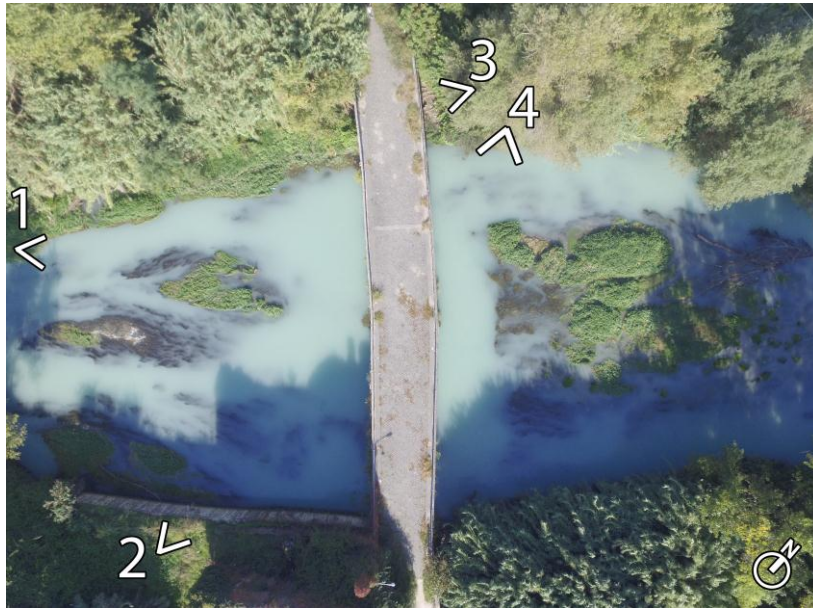
Thermographic investigations allowed to better understand the previously described state of degradation of Ponte Lucano, especially in regards to the presence of humidity. The test campaigns were carried out in two days of January 2019 at different times, by using an infrared camera model Testo 885-2 (resolution of 320x240, thermal sensitivity <30 mK at 30°C). The first inspection was made on January 26<sup>th</sup> at 11.30 a.m. in sunny weather condition and with an ambient temperature of 13°C; the latter on January 29<sup>th</sup> at 05.00 p.m. with similar environmental conditions, but without solar radiation, with an ambient temperature of 9°C. Heavy rainfalls occurred during the days between the two testing campaigns. In both campaigns the South and the North front of the bridge were analyzed as a whole, while more detailed images were shot to Arch I and Arch IV, more precisely from the North side and the South side, respectively, as depicted in Figure 10. As already observed in Section 4.1, the South side of the bridge is affected by a more advanced state of degradation, in particular of black crust, lack of material, vegetation and biological patina diffused both on the masonry and on concrete surfaces (Figure 11(a)).

Figure 10. Location of the cones of vision used in thermographic investigations.
